**Flood Control Project Maintenance
Levee Inspections**

Fall 2013 Levee Maintenance Deficiency Summary Report

Reclamation District No. 2103 Wheatland Vicinity

Levee Inspection Report By Mile - Fall 2013

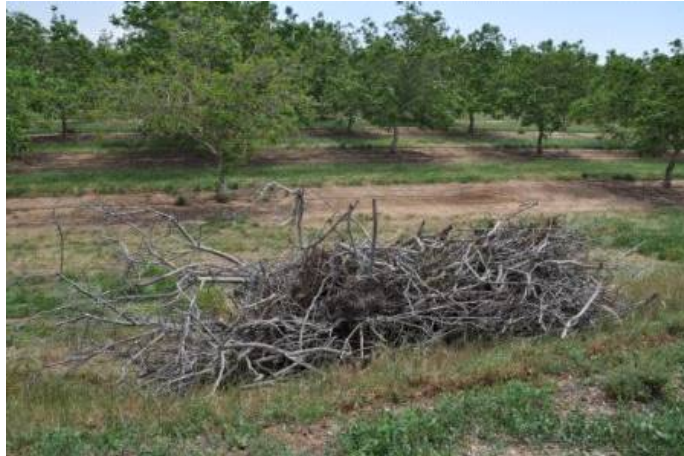
Levee Mile Report Line	6
Start Levee Mile	0.73
End Levee Mile	0.73
Location	Land Side
Category	Earthen Levee
Item	Encroachments

LMR No.	Levee Mile		Category	Item	Location * + Rating	Action/Comment	GPS Latitude/Longitude		Issue No.
	Start	End					Start	End	Photo
1			Earthen Levee	Flood Preparedness & Training	WS M Ma		°	°	2
DWR ID: DWR_RD2103_01_s_2012_2									
2			Earthen Levee	Operations & Maintenance Manuals	WS A Ma		°	°	5
DWR ID: DWR_RD2103_01_s_2013_5									
3			Earthen Levee	Emergency Supplies & Equipment	WS A Ma		°	°	6
DWR ID: DWR_RD2103_01_s_2013_6									
4	0.01	0.48	Earthen Levee	Encroachments	WS M En	FE : Fence	39.019849 ° -121.453871 °	39.021775 ° -121.445642 °	11
DWR ID: DWR_RD2103_01_f_2013_11									
5	0.39	0.39	Earthen Levee	Vegetation	WS M Ma	V2 : Remove the wild growth other than native grasses from the levee slopes. Inspector Comments: Berry bushes have been sprayed but need to be removed.	39.021448 ° -121.447252 °	39.021448 ° -121.447252 °	12
DWR ID: DWR_RD2103_01_f_2013_12									
6	0.73	0.73	Earthen Levee	Encroachments	LS M En	PR : Prunings Inspector Comments: Two pruning piles approx. 200ft apart on L/S slope.	39.022892 ° -121.444529 °	39.024105 ° -121.442552 °	4 Y

L/S slope pruning pile.

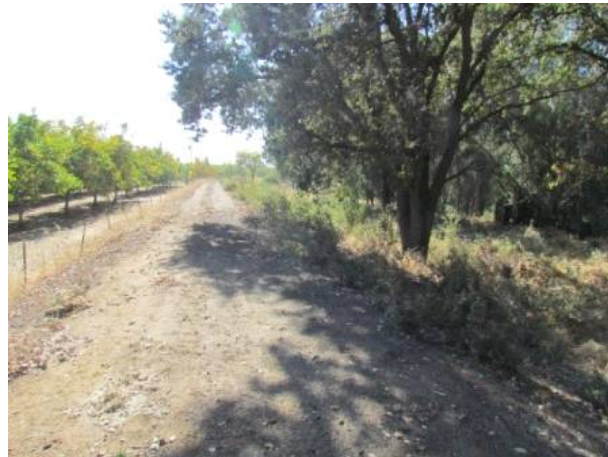
Levee Mile Report Line	11
Start Levee Mile	4.52
End Levee Mile	4.58
Location	Water Side
Category	Earthen Levee
Item	Vegetation

This photo was taken from the crown of the levee facing west looking at the vegetation on the waterward slope of the levee.

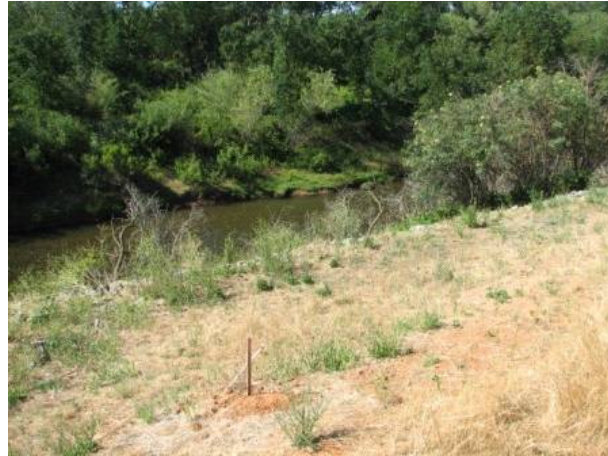
Waterway						Bank	Unit Miles	Inspection Start/End	Inspector	
Unit No. 02 Bear River						Right	5.00	10/15/2013 10/15/2013	Matthew Hoffman	
LMR No.	Levee Mile		Category	Item	* Location	** Rating	Action/Comment	GPS Latitude/Longitude		Issue No.
	Start	End						Start	End	Photo
1	0.30	0.51	Earthen Levee	Riprap Revetments	WSA/W	Ma	Inspector Comments: The District has a concern dead trees placed in the rip rap may not stay in place during a high water event.	38.994660 ° -121.432170 °	38.995537 ° -121.428535 °	4 Y
DWR ID: DWR_RD2103_02_s_2012_4										
2	0.32	0.49	Earthen Levee	Vegetation	WSA/W	Ob	V8 : Environmental Requirements.	38.994756 ° -121.431809 °	38.995450 ° -121.428893 °	3 Y
DWR ID: DWR_RD2103_02_f_2013_3										
3	0.65	0.65	Earthen Levee	Trim / Thin Trees	WS	C Ma	T1 : Trim trees to at least five feet above ground level.	38.996076 ° -121.426157 °	38.996076 ° -121.426157 °	2 Y
DWR ID: DWR_RD2103_02_s_2013_2

Levee Mile Report Line	1
Start Levee Mile	0.30
End Levee Mile	0.51
Location	Water Side
Category	Earthen Levee
Item	Riprap Revetments
Trees at waters edge in the rip rap levee mile 0.30.	
mhoffman_f_20130917_132.jpg

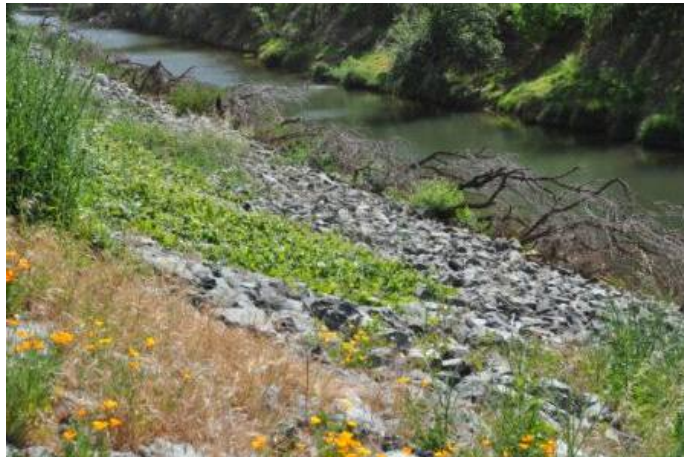
Levee Mile Report Line	1
Start Levee Mile	0.30
End Levee Mile	0.51
Location	Water Side
Category	Earthen Levee
Item	Riprap Revetments
View of revetment with dead trees, Spring 2013.	
mhoffman_f_20130917_133.JPG

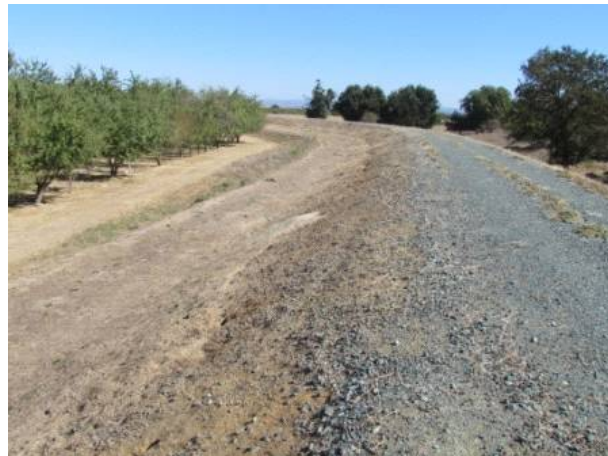
4	0.76	0.76	Earthen Levee	Animal Control	LS	U Ma	A1 : Exterminate rodents and backfill and compact or grout burrows. Inspector Comments: Large squirrel hole in the landward slope of the levee.	38.996588 ° -121.424209 °	38.996588 ° -121.424209 °	1 Y
DWR ID: DWR_RD2103_02_f_2013_1										
5	2.59	2.59	Earthen Levee	Crown Surface / Depressions / Rutting	CR	M Ma	C2 : Repair depressions or ruts in the crown or slope.	39.008356 ° -121.397283 °	39.008356 ° -121.397283 °	6 Y
DWR ID: DWR_RD2103_02_f_2013_6										
6	2.64	2.64	Earthen Levee	Vegetation	LS	U Ma	V4 : Elderberries are blocking visibility and flood fight capability. Inspector Comments: Large elderberry bush on L/S slope.	39.009077 ° -121.397318 °	39.009077 ° -121.397318 °	7 Y
DWR ID: DWR_RD2103_02_s_2013_7										
7	4.97	4.97	Earthen Levee	Vegetation	WS	M Ma	V2 : Remove the wild growth other than native grasses from the levee slopes.	39.031426 ° -121.367073 °	39.031426 ° -121.367073 °	8 Y

Levee Mile Report Line	4
Start Levee Mile	0.76
End Levee Mile	0.76
Location	Land Side
Category	Earthen Levee
Item	Animal Control
This photo was taken from the levee crown facing east looking down the landward levee slope at a large squirrel hole.	
mhoffman_f_20131016_659.JPG

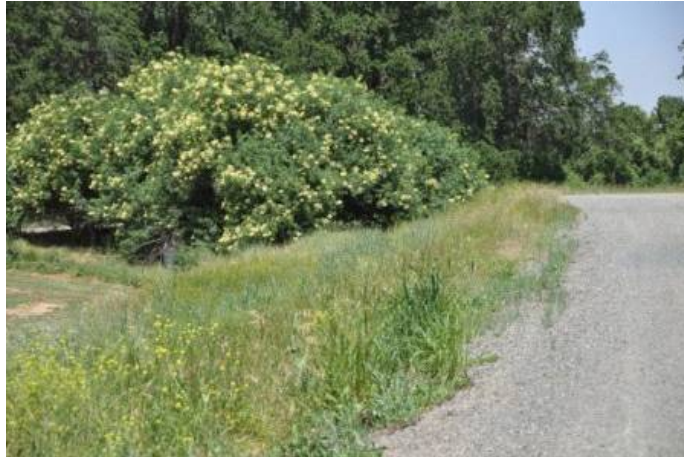
Levee Mile Report Line	6
Start Levee Mile	2.64
End Levee Mile	2.64
Location	Land Side
Category	Earthen Levee
Item	Vegetation
Large elderberry bush on L/S slope.	
mhoffman_f_20130917_135.JPG
